Bumper/Fascia Replacement with Advanced Driver Assistance Systems (ADAS)

January 2020

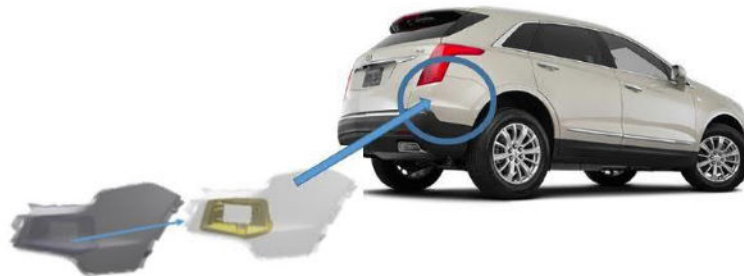
Figure 1.1

Depending on vehicle build configuration, the Bumper/Fascia system may have ADAS sensors attached to the inner surface that are not visible from the exterior of the vehicle (Please refer to Figure 1.1). GM is limiting repairs to these Bumper/Fascia systems on vehicles equipped with ADAS.

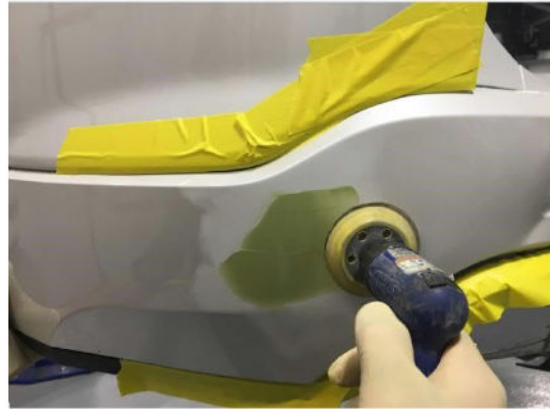
Any Bumper/Fascia equipped with ADAS(s) that requires substrate repair must be replaced. An example of substrate repair is shown in Figure 1.2
