-----  
**Location of radar sensors in front bumper, shown on model 221**

**Location of radar sensors in rear bumper, shown on model 221**

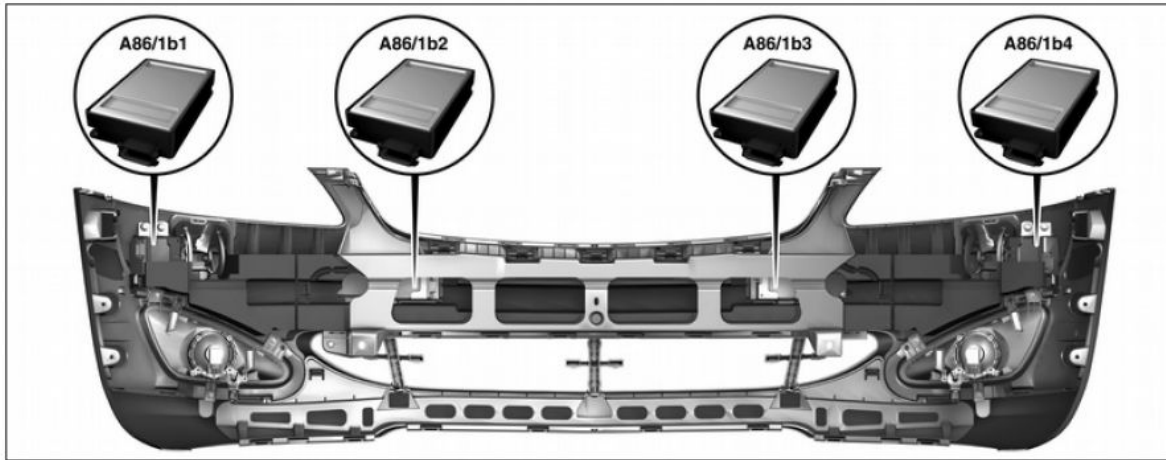
P30.30-2075-08

*A86/1b1 Left outer radar sensor*

*A86/1b2 Left inner radar sensor*

*A86/1b3 Right inner radar sensor*

*A86/1b4 Right outer radar sensor*

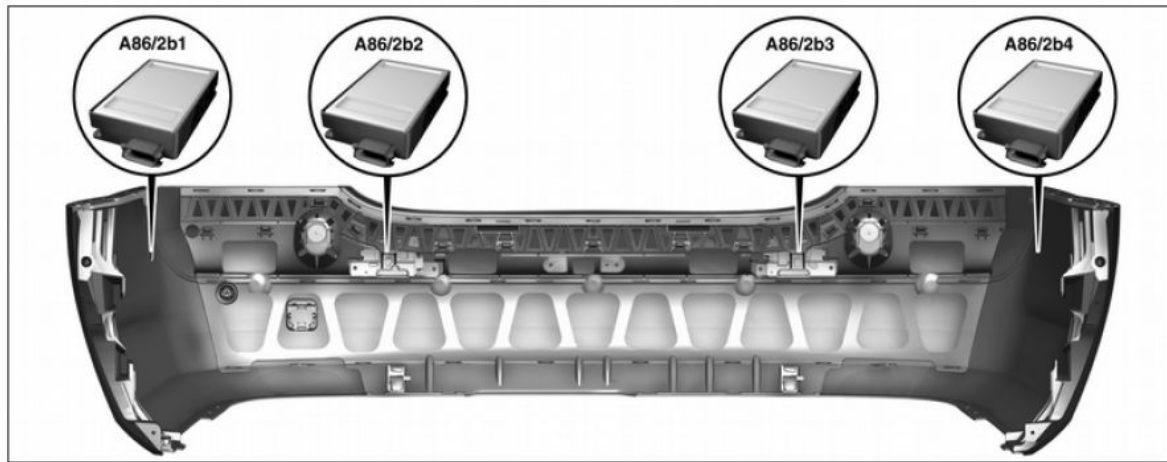
P30.30-2076-08

*A86/2b1 Right outer radar sensor*

*A86/2b2 Right inner radar sensor*

*A86/2b3 Left inner radar sensor*

*A86/2b4 Left outer radar sensor*
